Anacostia River & Oxon Run Watershed Stream Restoration Projects

September 20, 2023

National Park Service
U.S. Department of the Interior

Park Drive Stream Restoration

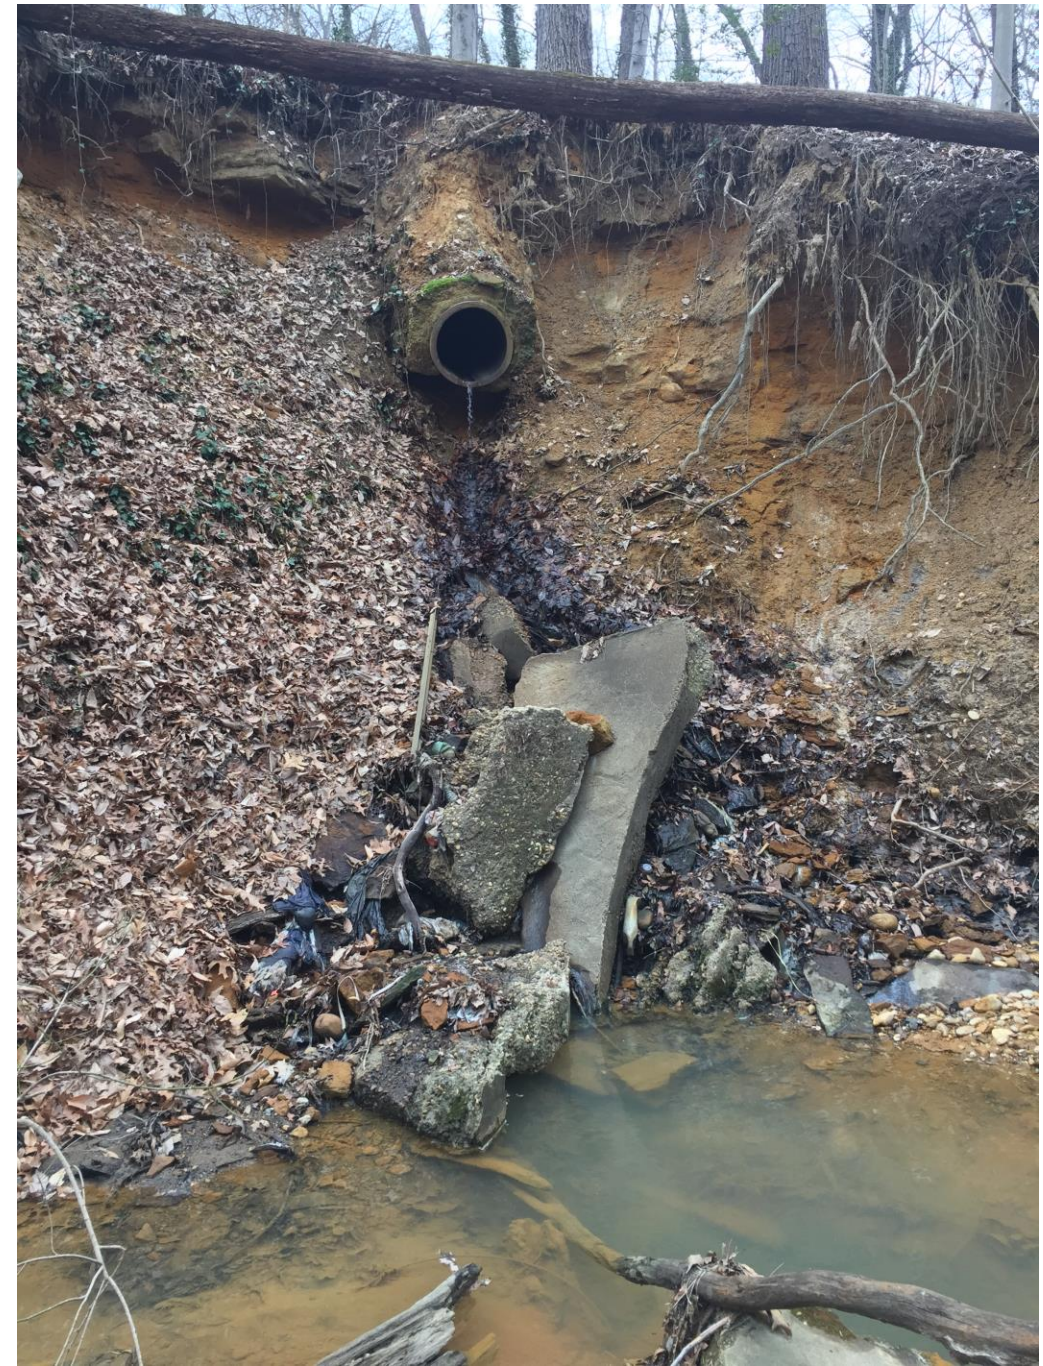
Park Drive - Existing Site Conditions

- Active streambank erosion and channel incision are occurring within the stream segment.
- Headcuts are occurring at the tributaries and drainage channels primarily from unmanaged stormwater flows.
- Collapsing stormwater outfalls and head cutting back toward roadways.
- Trees along the stream have fallen due to channel widening.
- Trash and debris are dumped into the site from the roadway and enter the site via the stormsewer system.
- Japanese knotweed, a highly invasive plant species, has overtaken an area along Park Drive near Site 2.

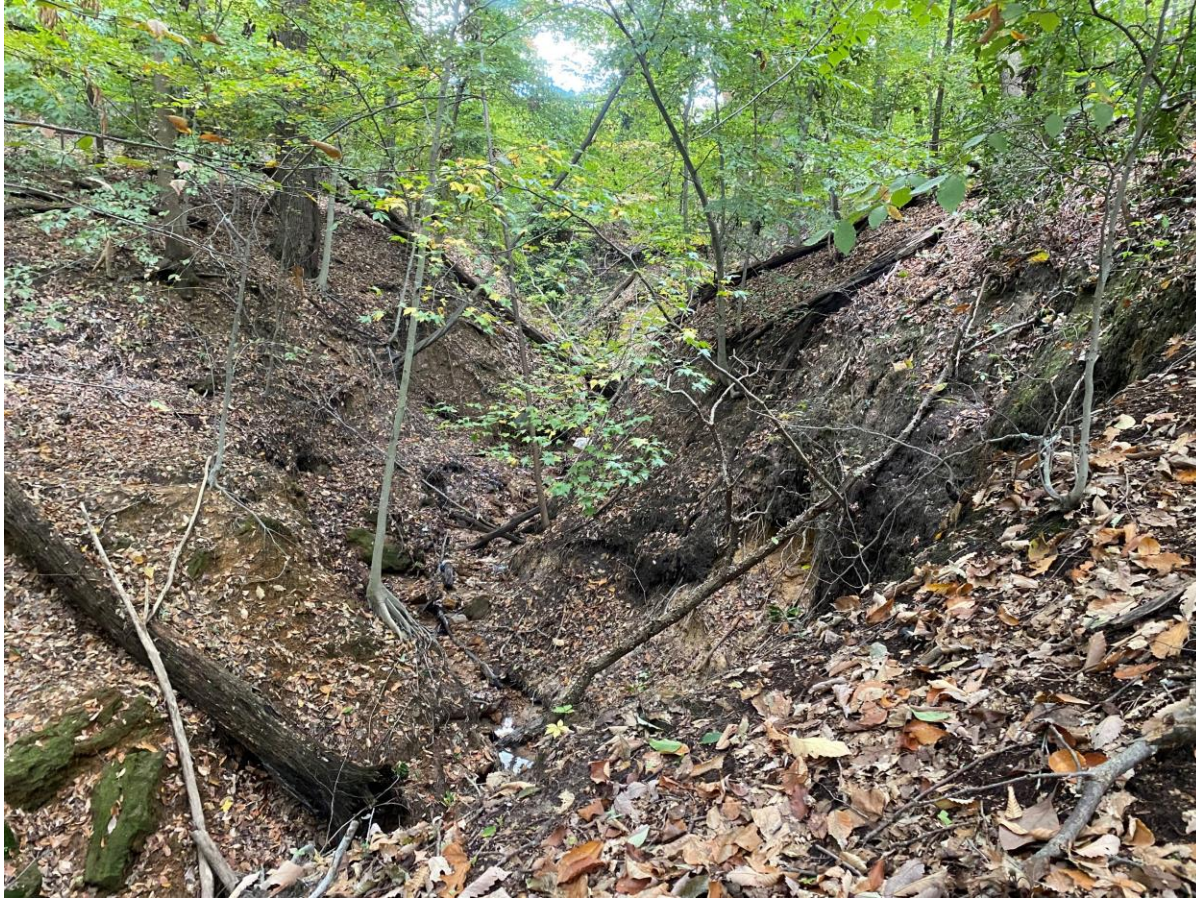
Existing Site Conditions

Expected Changes Post Restoration

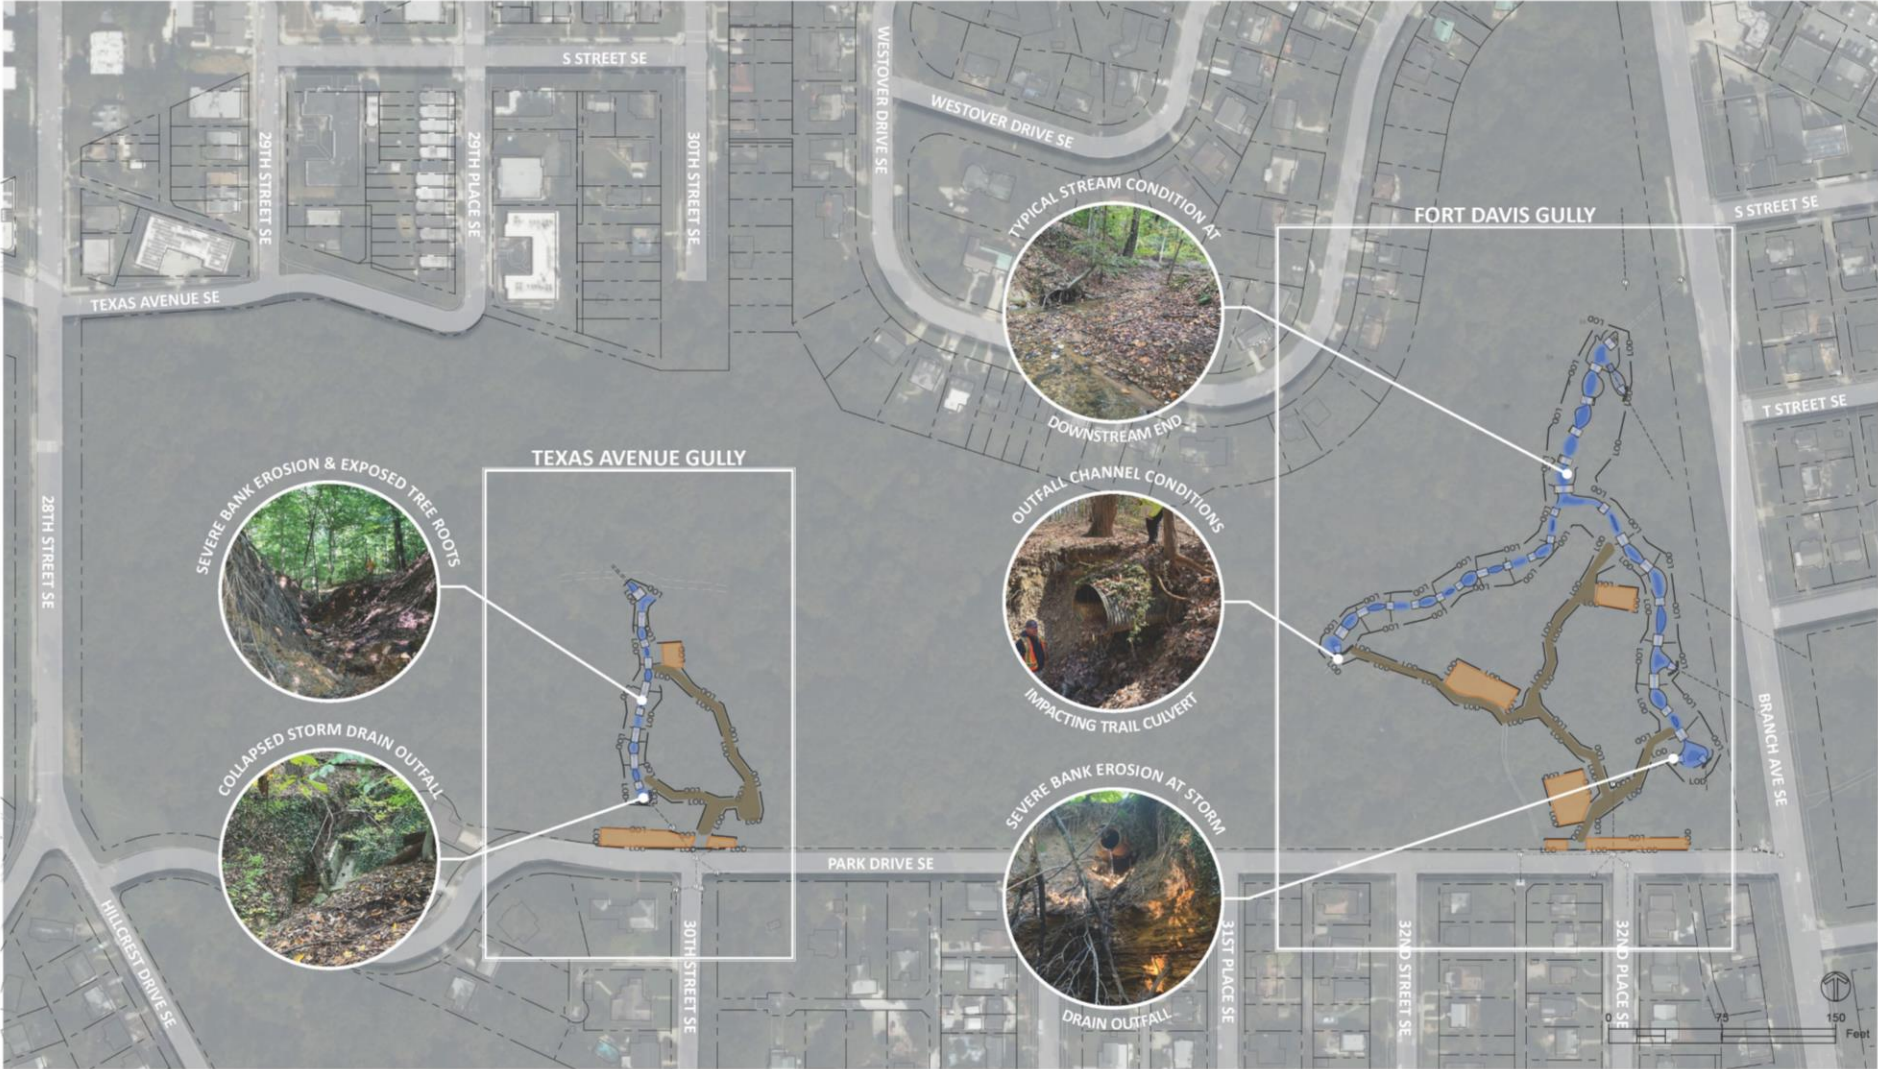
Restoration Design Approach – Construction Access

PARK DRIVE GULLY OUTFALL AND STREAM RESTORATION
TEXAS AVE & FORT DAVIS GULLY - PROPOSED CONDITION VICINITY PLAN
WASHINGTON, DC

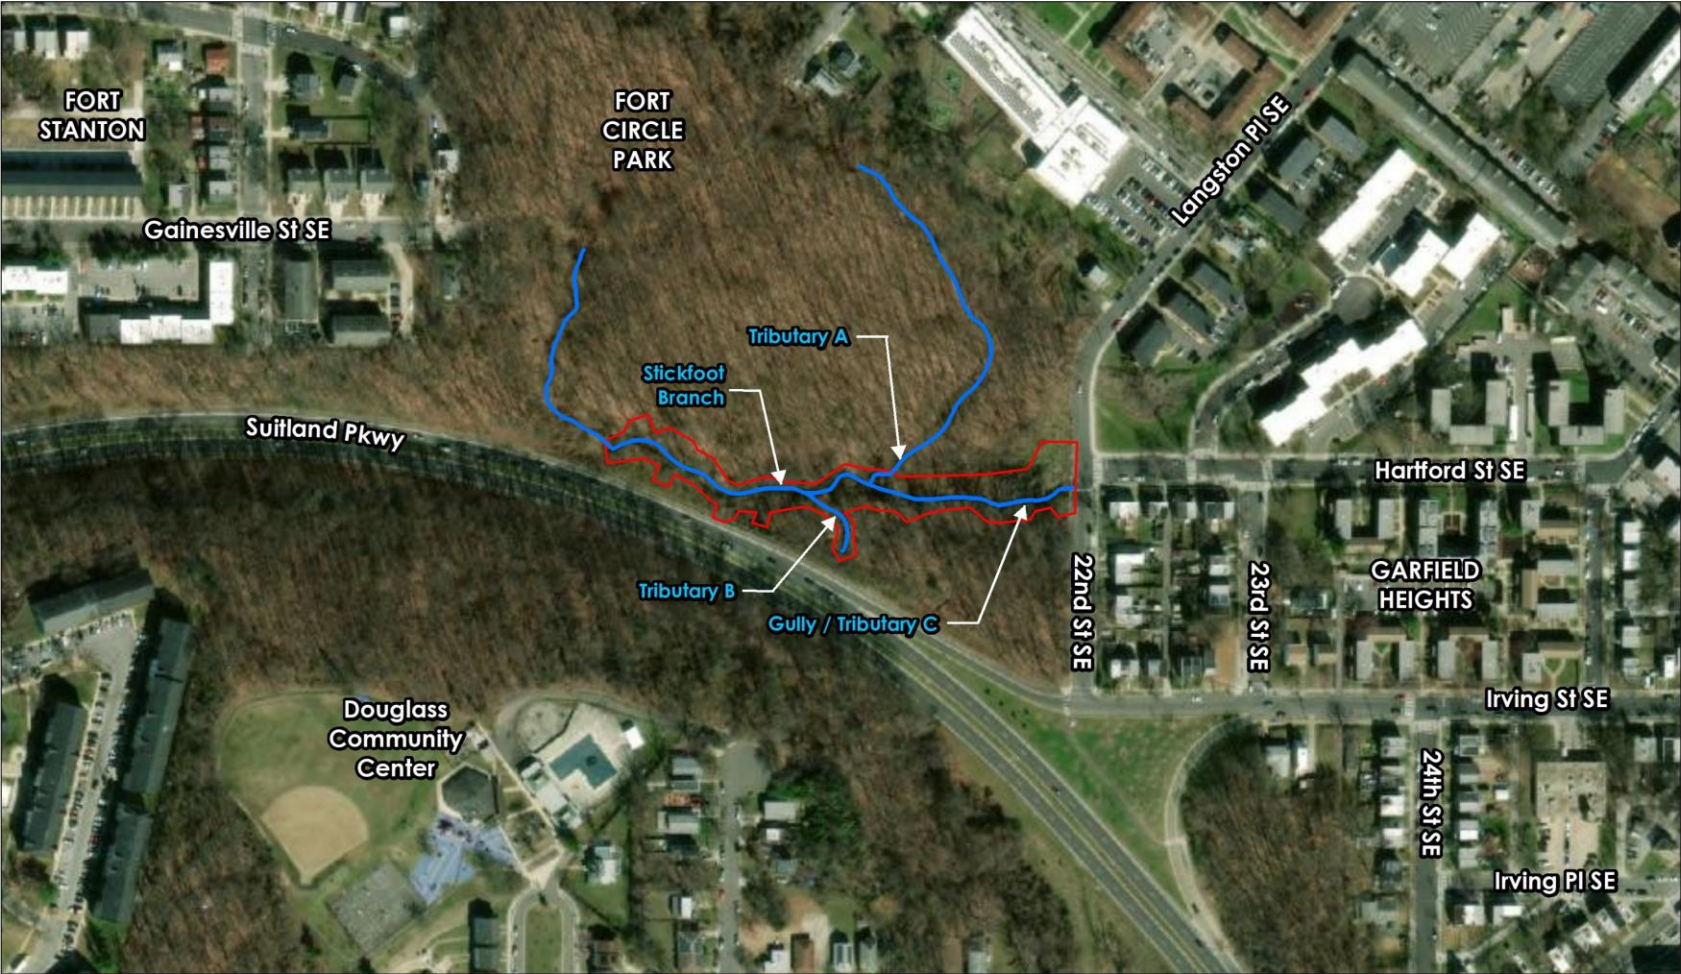
Project
Stickfoot Branch Stream Restoration Project
 Figure No.
1
 Title
Study Area Map

- Stickfoot Branch Stream Restoration Study Area
- Local Hydrography

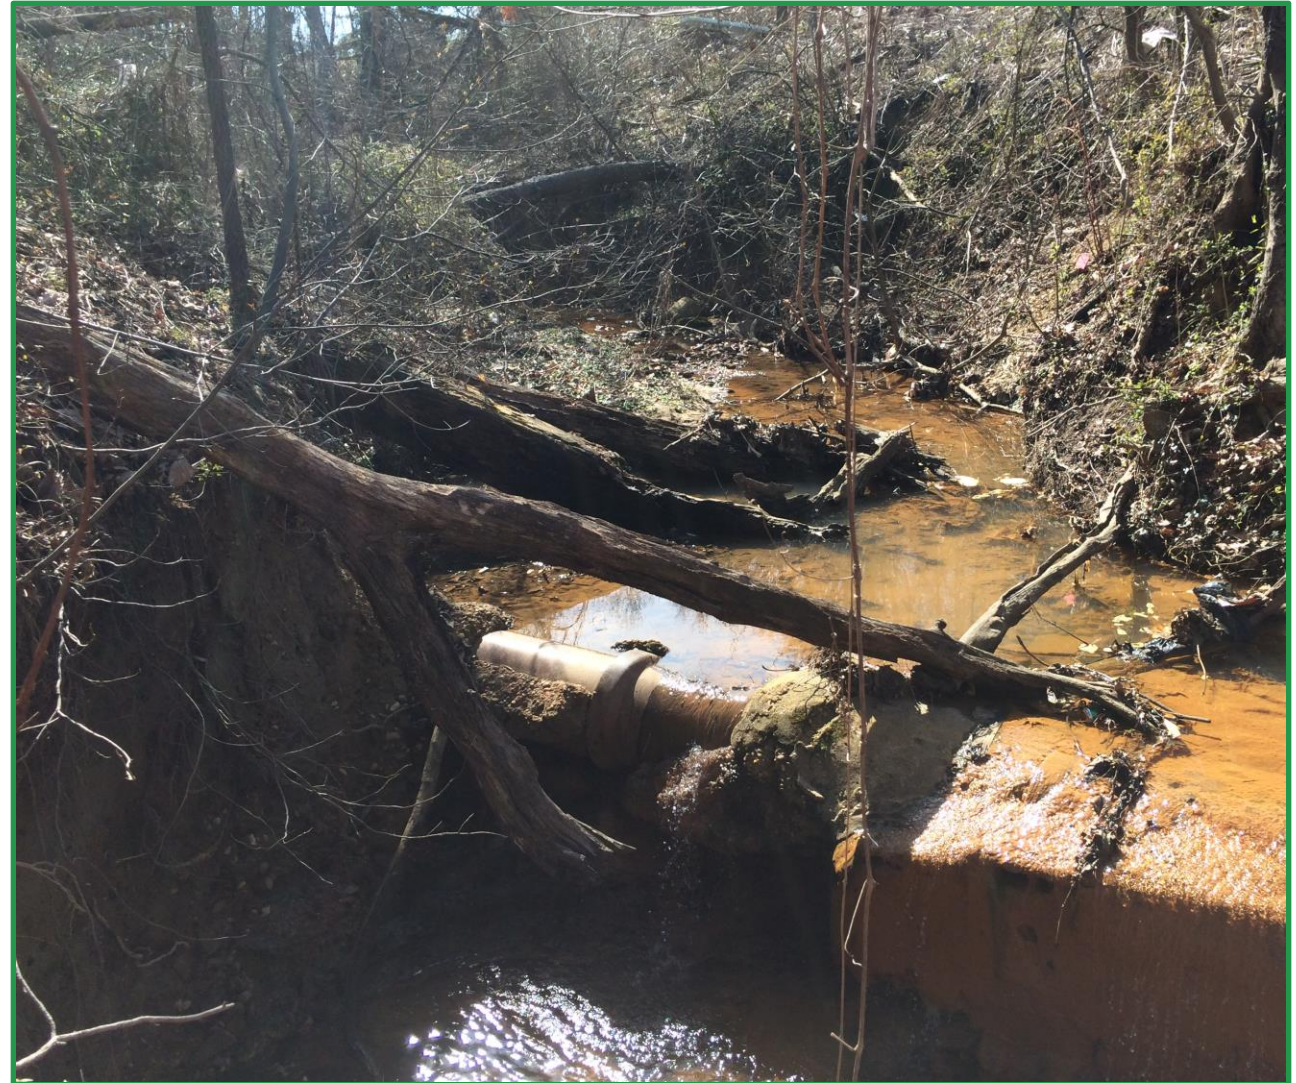
Stickfoot Branch - Existing Site Conditions

- Active streambank erosion and channel incision are occurring within the stream segment.
- Headcuts are occurring at the tributaries and drainage channels primarily from unmanaged stormwater flows.
- Concrete encased sewer lines that cross Stickfoot Branch have become exposed.
- Trees along the stream have fallen due to channel widening.
- A large gully has formed on the embankment of 22nd Street SE due to unmanaged stormwater flows.
- Kudzu, a highly invasive plant species, has overtaken the northeast portion of the study area.

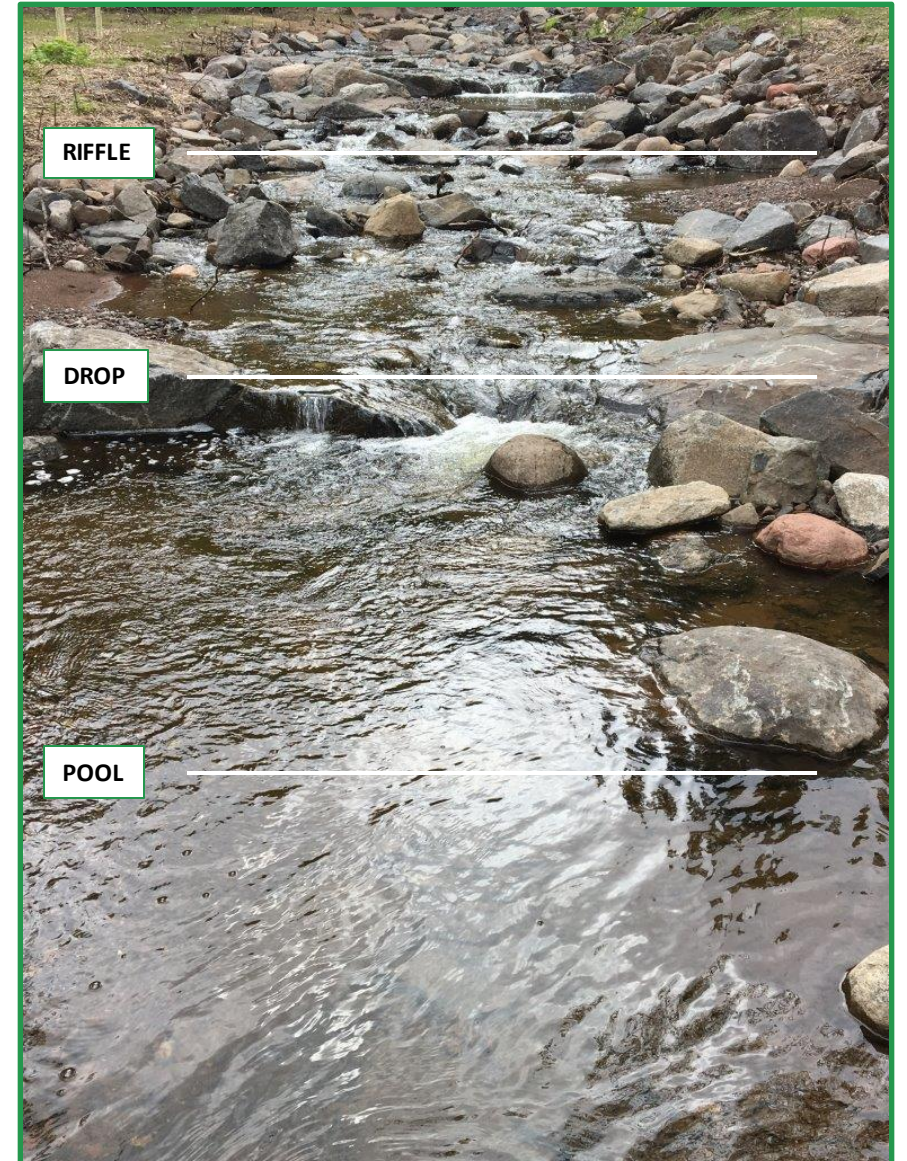
Restoration Design Approach

- Restore Stickfoot Branch using a roughened channel design approach that mimics natural stream channels
- Install buried boulder sills to prevent channel downcutting and to protect sewer infrastructure
- Place rocks to promote flow diversity (drops, pools, and riffles)
- Remove piped sections of stream to increase length of natural channel design
- Restore side tributaries and drainage channels
- Implement invasive species management practices to control kudzu

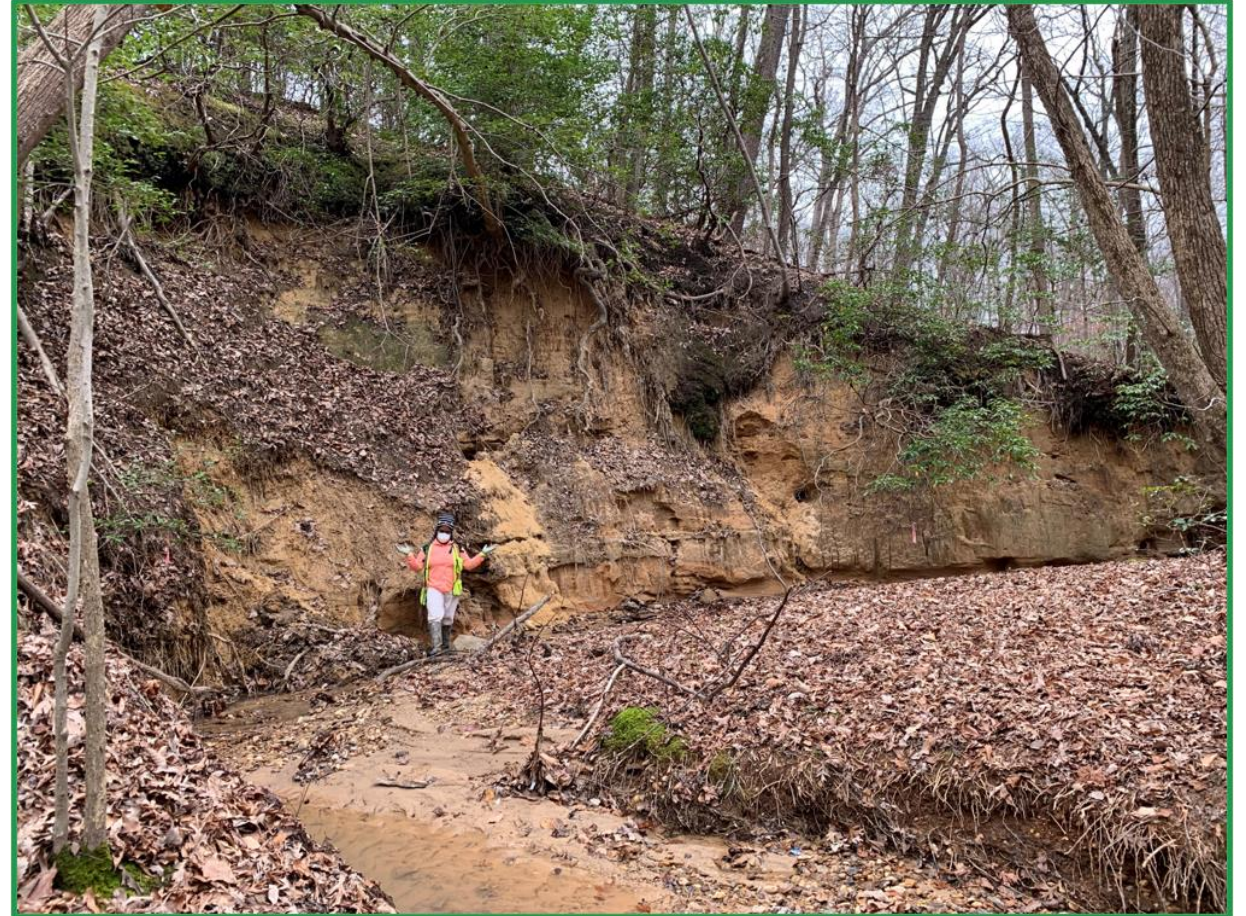
Fort Dupont Existing Conditions

Active, extreme streambank erosion and channel incision are occurring within the stream segment.

Headcuts are occurring at the tributaries and drainage channels primarily from unmanaged stormwater flows.

Aging infrastructure within the stream valley are being impacted by stream channel instabilities.

Trees along the stream have fallen due to channel widening.

Down cut stream channels are functioning as drainage gullies; dewatering wetlands and degrading stream habitat

Several species of highly invasive plant species have overtaken portions of the project area.

Sewer line infrastructure that cross Fort Dupont Creek have become exposed.

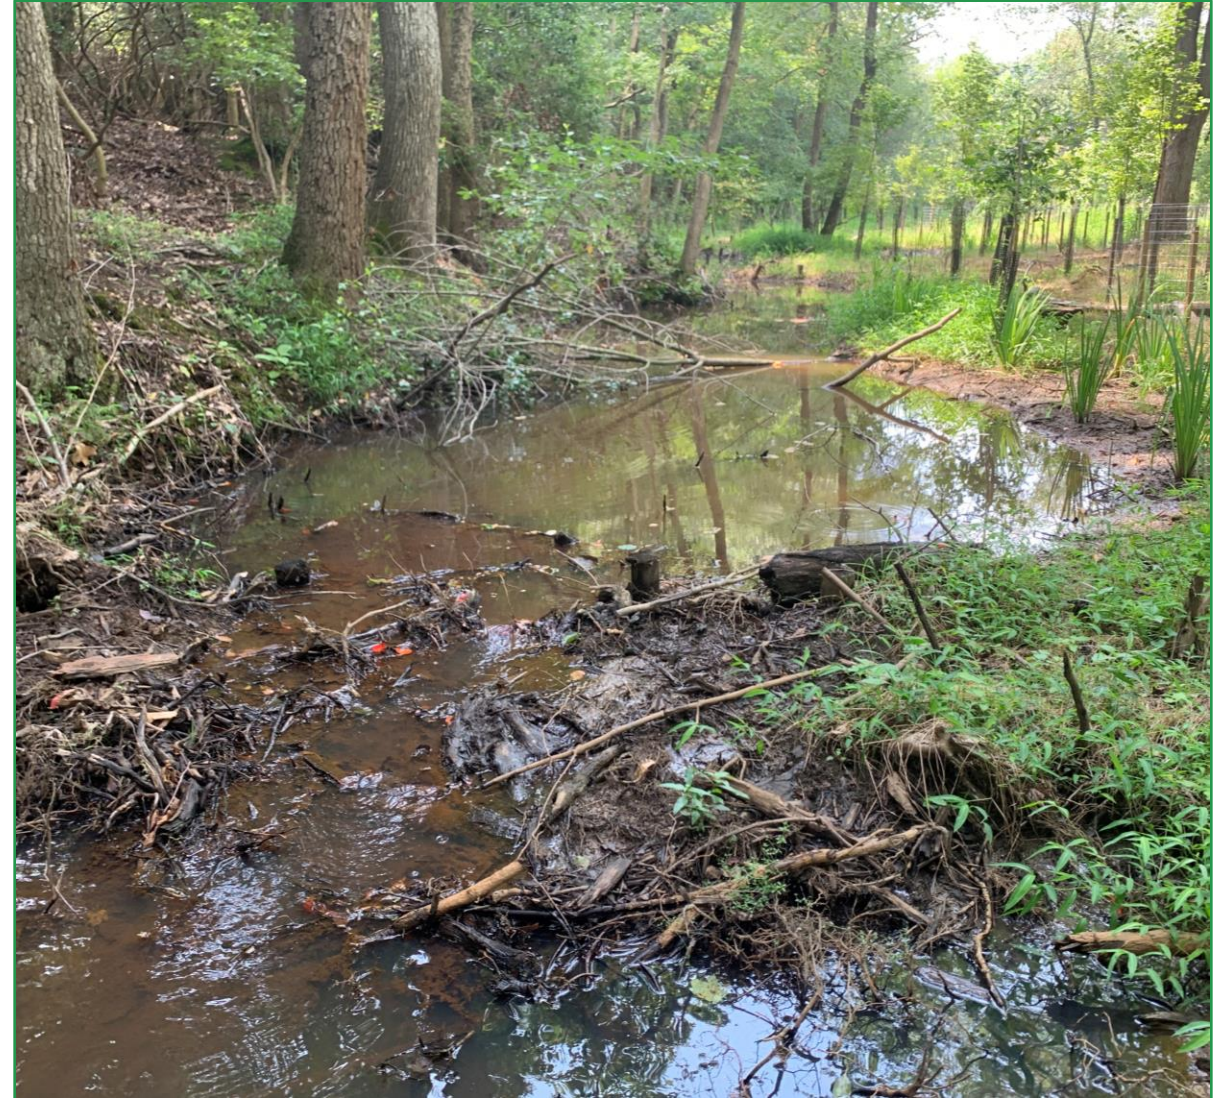
Restoration Design Approaches Overview

- Restore Fort Dupont Creek using a baseflow channel/floodplain reconnection approach that mimics natural stream channel functions
- Install grade stream control structures built from materials naturally found in coastal plain stream channels such as wood, gravels and cobbles to stabilize the stream.
- Ensure a diversity of habitat conditions within the stream to improve the aquatic resource
- Daylight sections of the stream that are currently piped
- Plant a variety of native trees, shrubs and herbaceous plants
- Implement invasive species management practices to control the spreads of non-native invasive plants

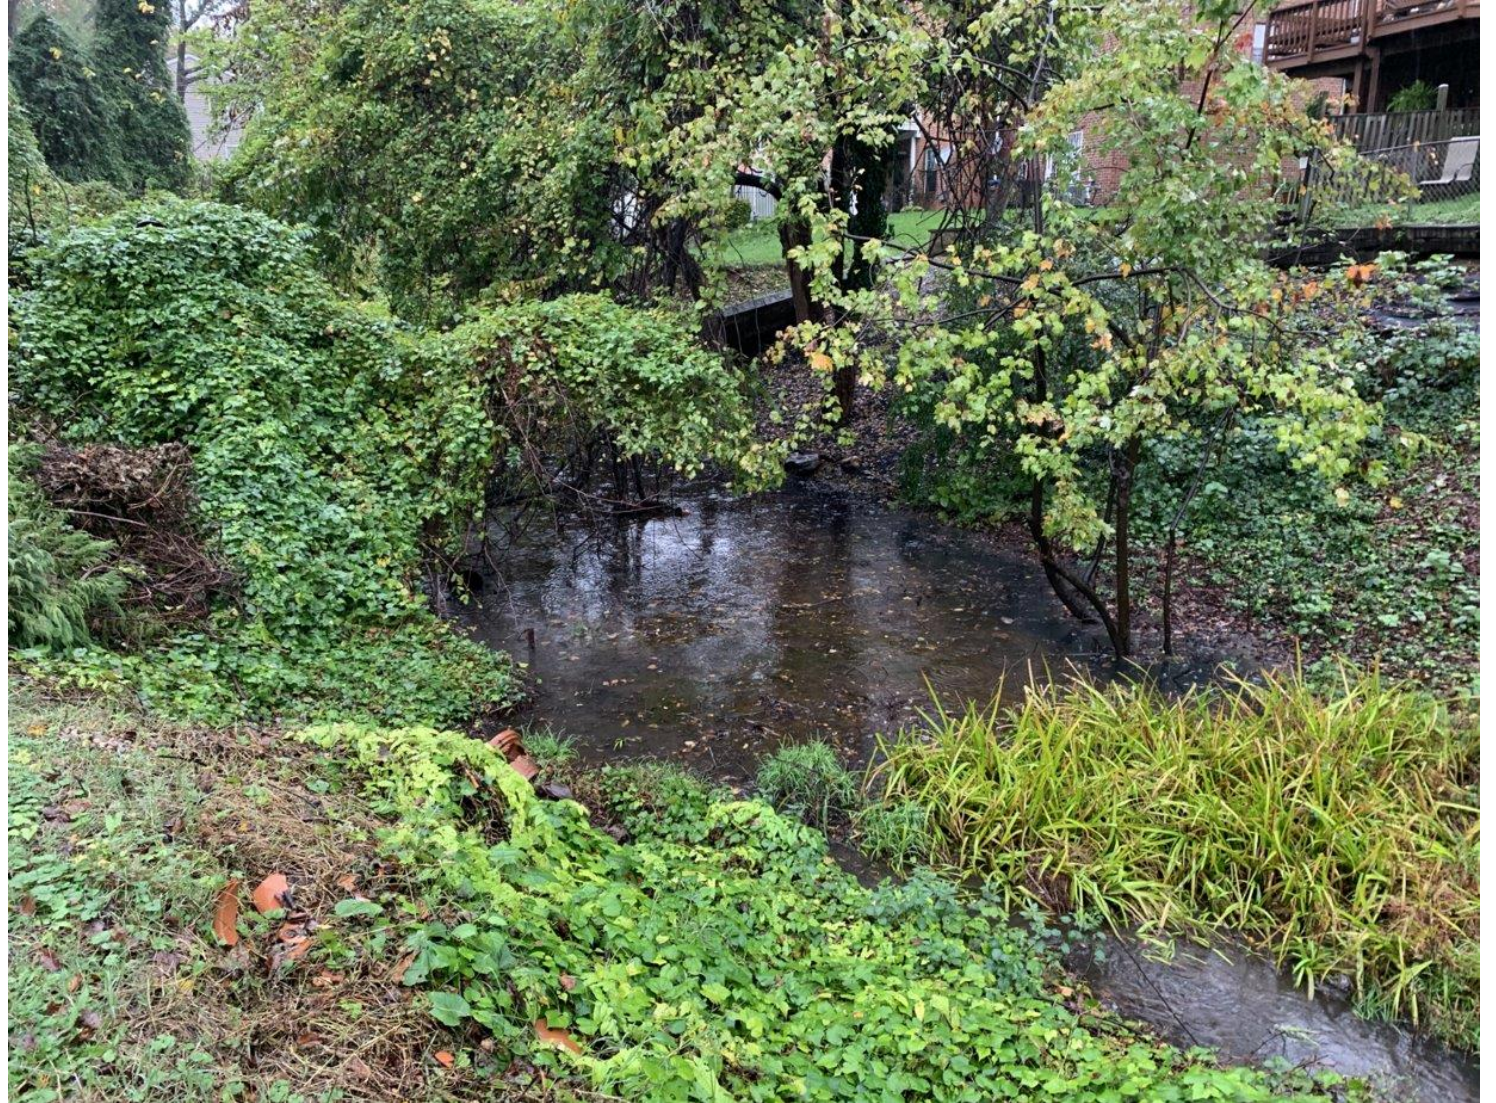
36th Pl. SE Wetland Restoration

- Small Wetland & Stream Complex
- Relatively flat center area with steeper side slopes
- Invasive Plant Species
- Debris at upstream end of project area
